Recent Test Results of GBCR3 @SLAC

Data Transmission Tests

19 March 2025

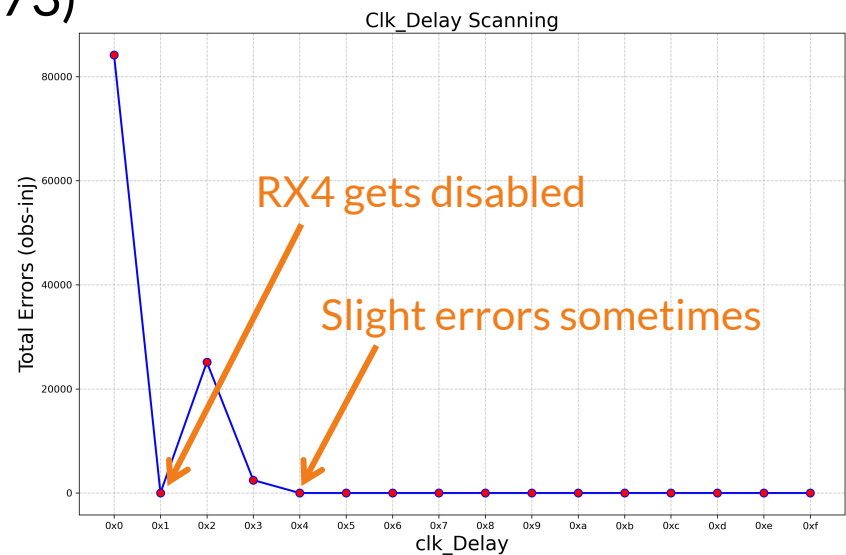
1st Test on RX4:
(GBCR3 C0073) ~68.8% good phase points

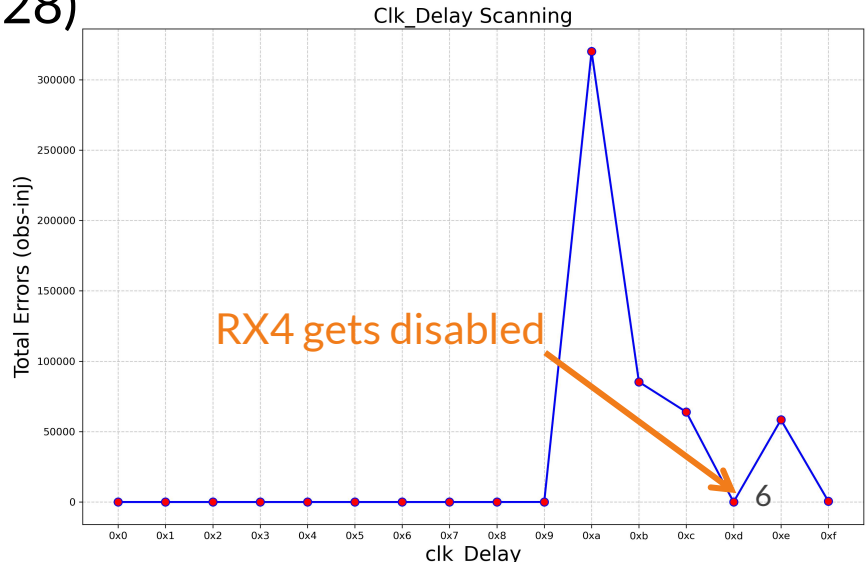
2nd Test on RX4:
(GBCR3 C2328) ~56.3% good phase points

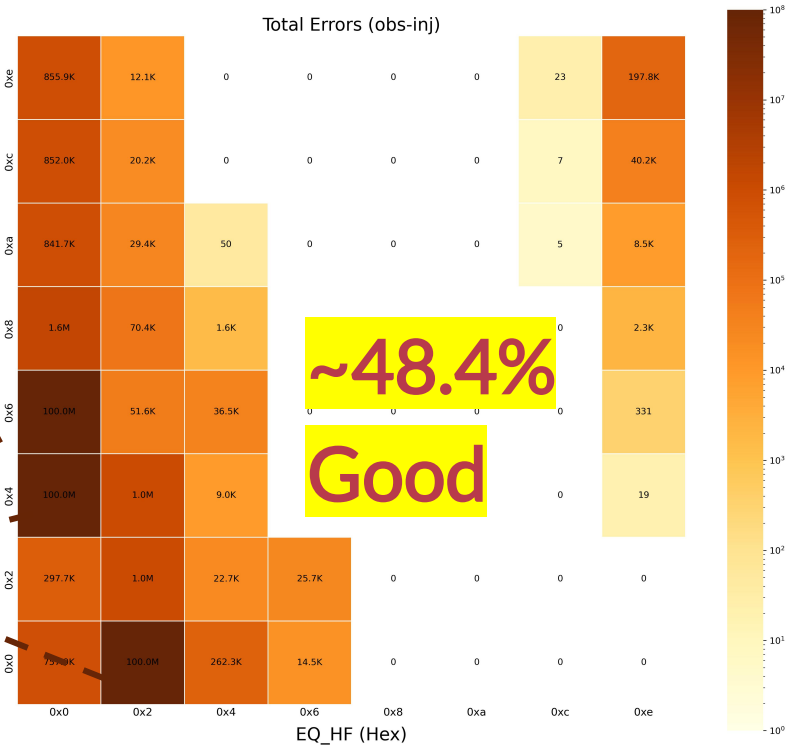
➤ HF vs MF Scanning on RX4:

(GBCR3 C2328)
(loss ~19dB@640MHz)

The channel gets disabled
