Recent Test Results of GBCR3 @SLAC

Data Transmission Tests

19 March 2025

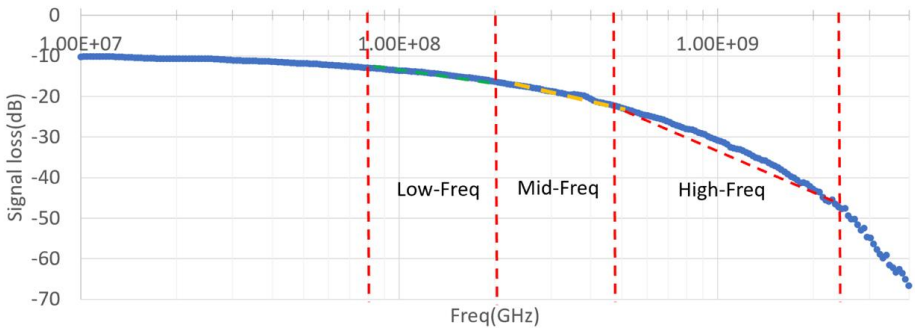
Data transmission loss in MF/HF range

➤ HF vs MF Scanning on RX4:

(GBCR3 C2328)
(loss ~19dB@640MHz)

The channel gets disabled
